CASE STUDY:
WREXHAM POLICE STATION
WALES, UK

GP[®]1 provides protective ground gas barrier solution for Wrexham Police Station

Cost effective measures, and the ability to demonstrate appropriate advice made JUTA UK the ideal partner to support the groundworks for Wrexham's new £21.5M police station.

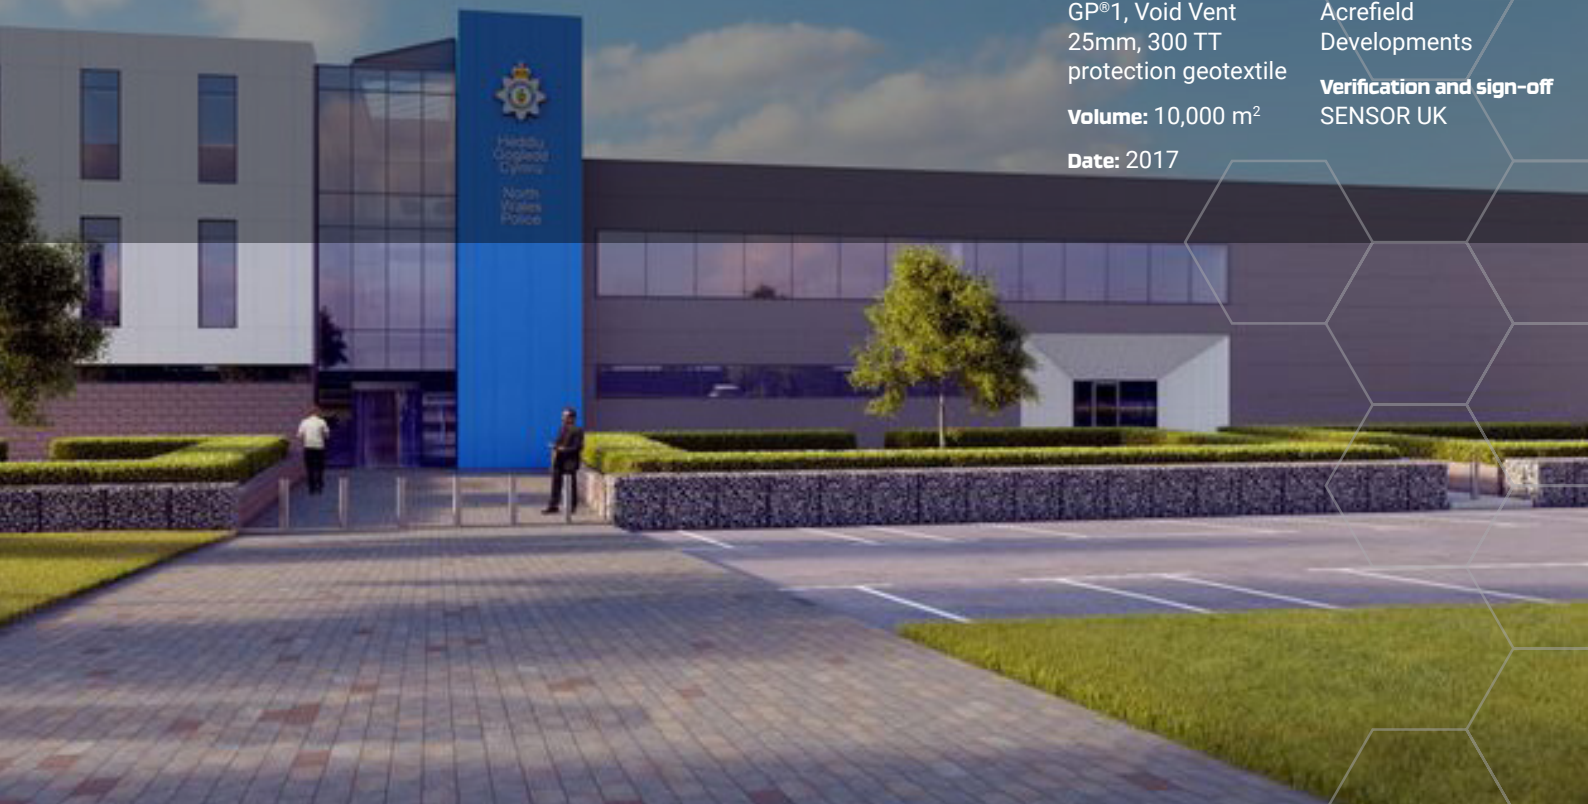
GP[®]1

**VOID VENT
25 MM**

**300 TT
PROTECTION
GEOTEXTILE**

GP[®]1, Void Vent
25mm, 300 TT
protection geotextile

A nominal underfloor venting system was also required to prevent gas becoming trapped below the floor slab. Void Vent 25 - a 25mm deep cusped geocomposite - was installed in designed 'strips', to provide a pressure relief below the slab, and provide a 'path of least resistance' for any migrating ground gas, allowing it to

A protective geotextile (300TT) was also included in the design, to be placed above the compacted subgrade to prevent damage to the GP®1 from underlying sharp materials. One thing we see removed often from gas membrane installation works is the protective geotextiles.

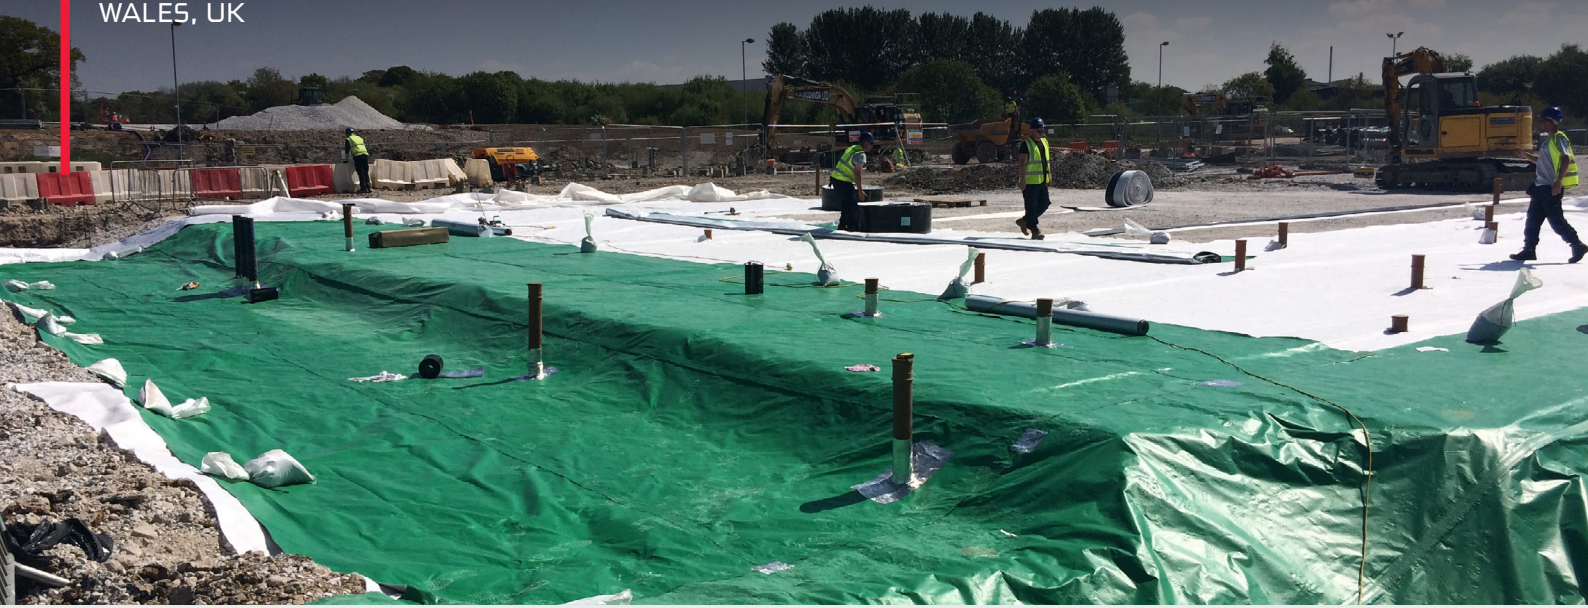
The 8,600 square metre site (now built) is an eco-friendly facility. The building generates its own electricity through photovoltaic panels and also harvests enough rainwater to help wash 25 vehicles a day. Utilising smart LED lighting technology it also conserves energy too.

The building itself comprises 32 custody cells and houses 248 officers and staff, acting as the main police HQ for Wrexham and Flintshire.

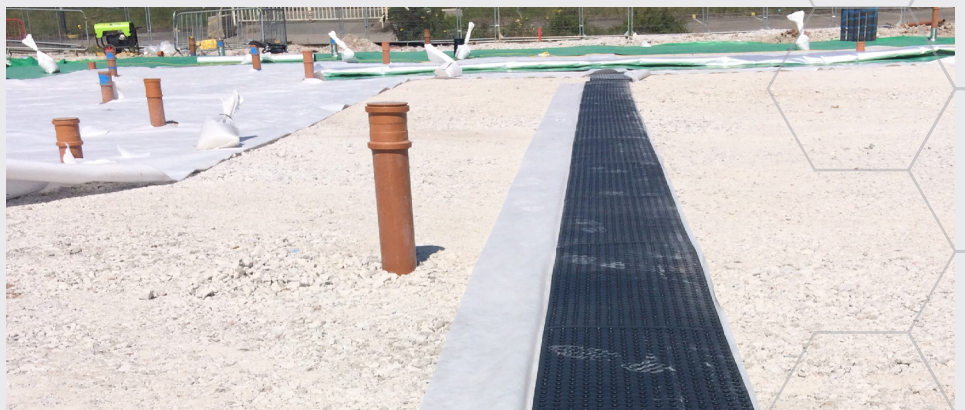
GP®1 - gas resistant damp proof membrane was selected for this project as the most appropriate and cost effective gas barrier solution. It's manufactured from virgin polymers, and designed to perform the critical application function of a 'barrier' to ground gas for at least 60 years.

GP®1 is a proven and sustainable method of protecting building inhabitants from potential harmful gas migration from the ground and is manufactured in accordance with the requirements of BS8485, and is the gas membrane of choice for ground gas professionals.

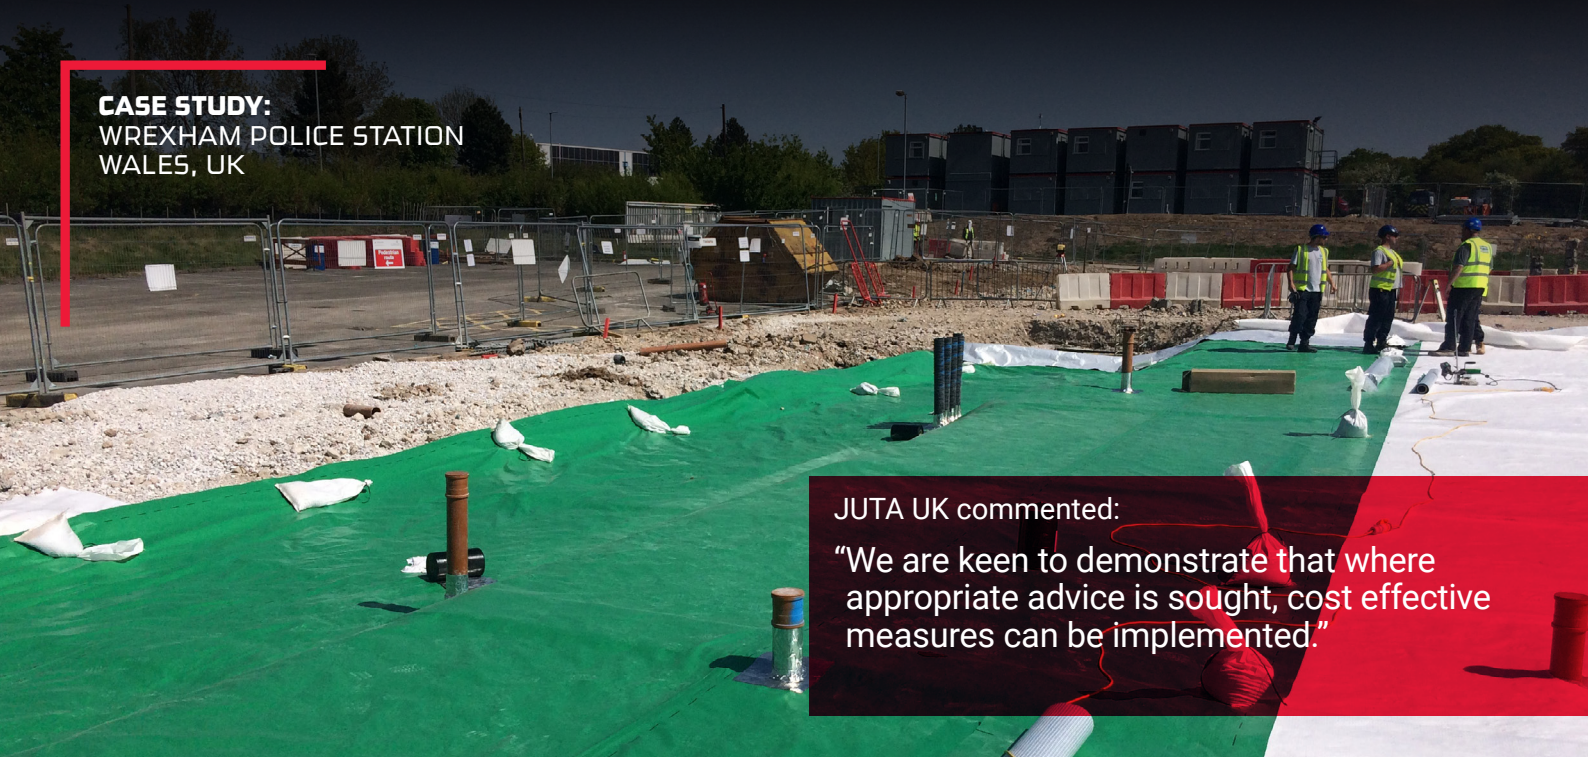
Critical to the success of any protective barrier install, is the quality of the workmanship. GP®1 was supplied and incorporated within the floor slab construction of the building by our specialist installer.

This ensured the highest standard of workmanship on site (NVQ level 2 gas membrane qualified installer, and TWI/CSIP plastic membrane qualified). The installation works were then checked and verified by an independent party to ensure discharge of relevant planning conditions.

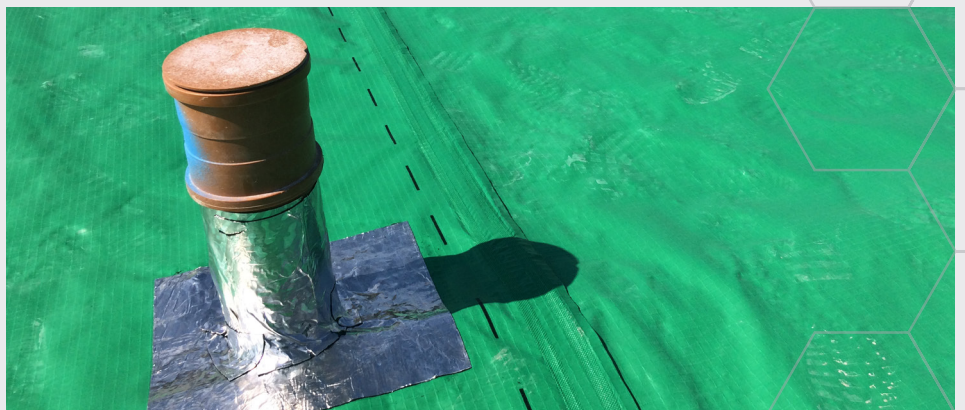
naturally permeate into the atmosphere unhindered. The function of the gas barrier is to provide resistance to the passage of ground gas into the building, while this natural migration of gas occurs to the atmosphere.
